# SERVICE BULLETIN

## COBRA

Details: Standard Mulch Blade Fitted

Models Effected: RM513SPBI - RM514SPC

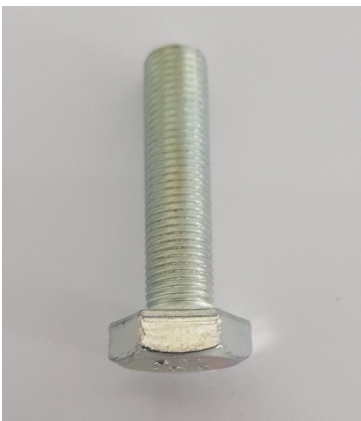
#### STEP 1

- RM513SPBI - RM514SPC poor collection.

- Standard mulch blade fitted in error, replacing with high lift blade setup.

Remove the blade bolt with a 17mm socket.
